SEISMIC DESIGNED BACKSLOPES AND EVALUATION
IN A STRUCTURALLY DISTURBED BASALT SECTION

A THESIS

RONALD E. LARSEN

APRIL 1976

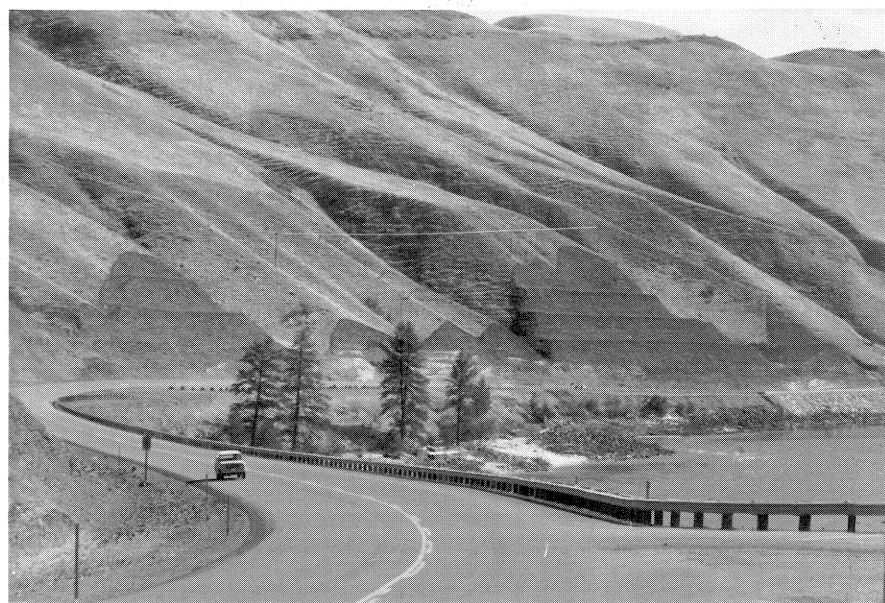
PHOTO NO. 1

M.P. 221.50
3/4:1 Colluvial Backslopes with 10' Benches every 50'

After the data was accumulated it appeared that most feasible slope designs would remain in colluvial debris. A $3/4:1$ slope with 10-foot benches for every 50 feet of vertical height was selected even though the natural slope was $1\frac{1}{2}:1$. This decision was based on excess quantity with a flatter slope and the fact that the existing cut slope was standing adequately on $1\frac{1}{2}:1$ slope. Another factor is the annual rainfall which amounts to 6"/year. No undisturbed soil samples were taken as the material was much too rocky to test, so the factor of safety is still unknown.

So far the slope has performed very well with only one small bench failure in the alluvial sand. See Photo No. 1.

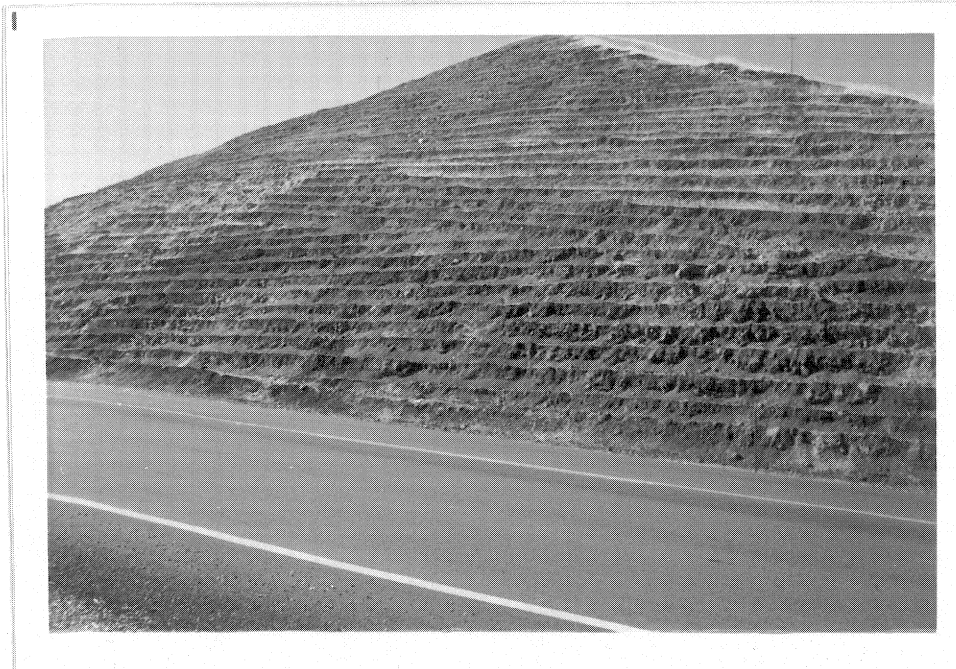
PHOTO NO. 2

Banner Ridge - $1\frac{1}{2}$:1 Mini-bench Slopes in an Altered Basalt

The recommendation was correct, the bulk (95 percent) of the cut was steeply dipping, hydrothermally altered, and structurally displaced. See Photo No. 2. The material throughout the cut is weathering and differentially sluffing back to the $1\frac{1}{2}$:1 overall slope. Hopefully the grasses will establish their roots and eliminate raveling and look asthetically appealing.

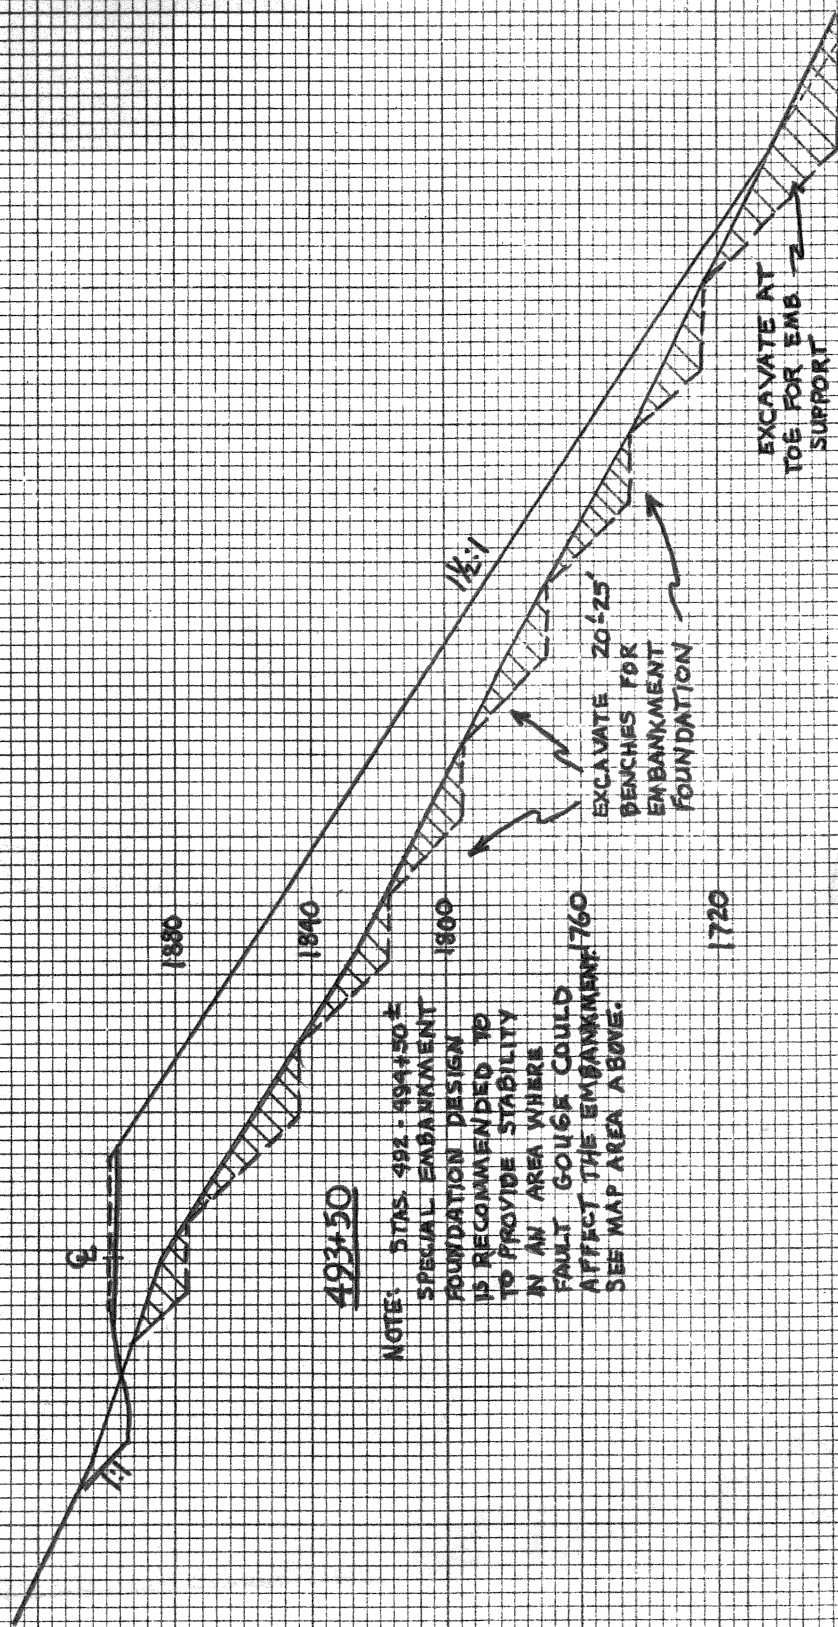
FIGURE NO. 1

For these reasons, a series of benches 20 to 25 feet wide, parallel to contour lines were excavated (See Figure No. 1) into bedrock in hopes of removing any potential slip surface, thereby keying the embankment into solid rock. At the embankment catch point, a larger bench was excavated into bedrock which would eliminate any potential base or toe failure.

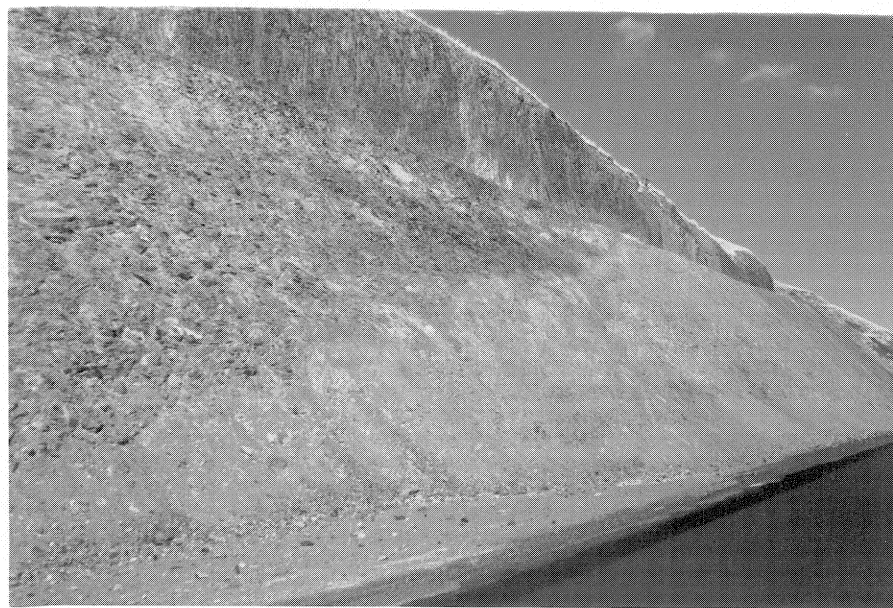
PHOTO NO. 3

M.P. 224.5
Constructed Backslope and Associated
Fault Gouge at Sta. 501

encountered at grade was designed on a 1:1 slope. It has remained in place with only minimal sluff. The high angle, down the valley fault plane, is exposed throughout much of the upper section. Slopes of 1/8:1 were proposed with 15' wide bench system to catch and retain falling rock. The slope has remained stable as the wall rock behind the shear plane is quite resistant to movement. (See Photo Nos. 3 and 4).

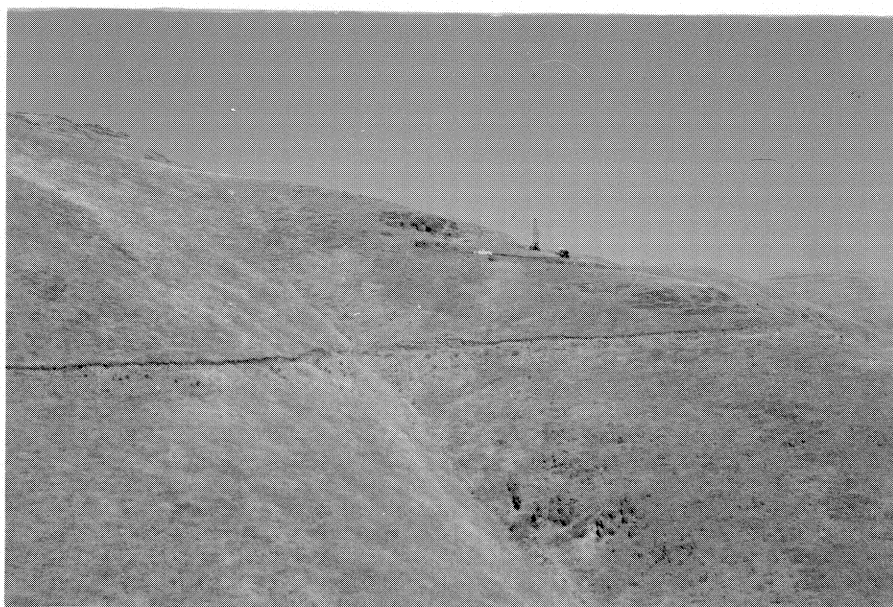
PHOTO NO. 5

M.P. 226.2
Sta. 590. Drill Investigation and Fault Limits

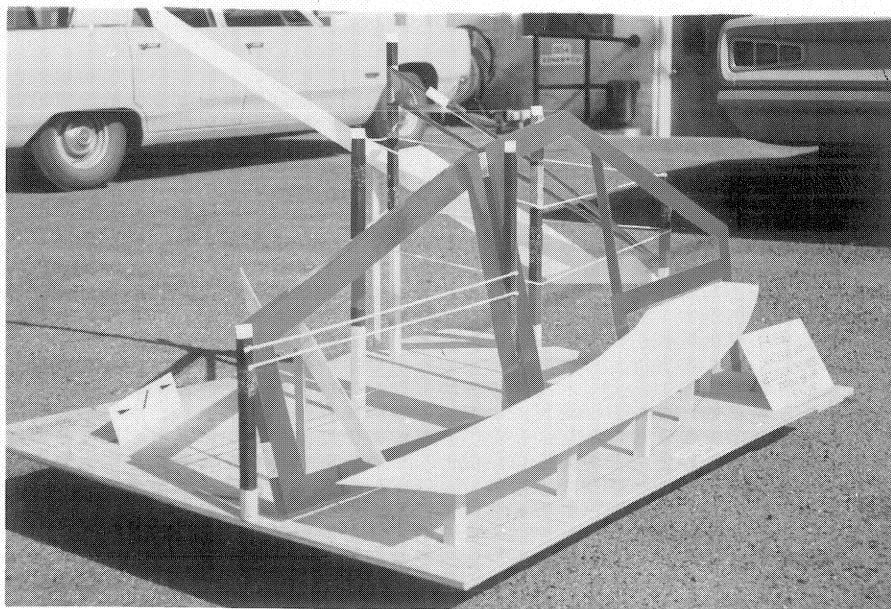
PHOTO NO. 6

Scale Model of Subsurface Conditions and Associated Fault Planes

It appeared that a low angle fault intersected the high fault left of centerline. The cuttings and core indicated highly fractured and altered basalt. A variable slope (1:1 to 1½:1) and bench was designed to eliminate the loading above a three-foot clay horizon in the low angle fault. See

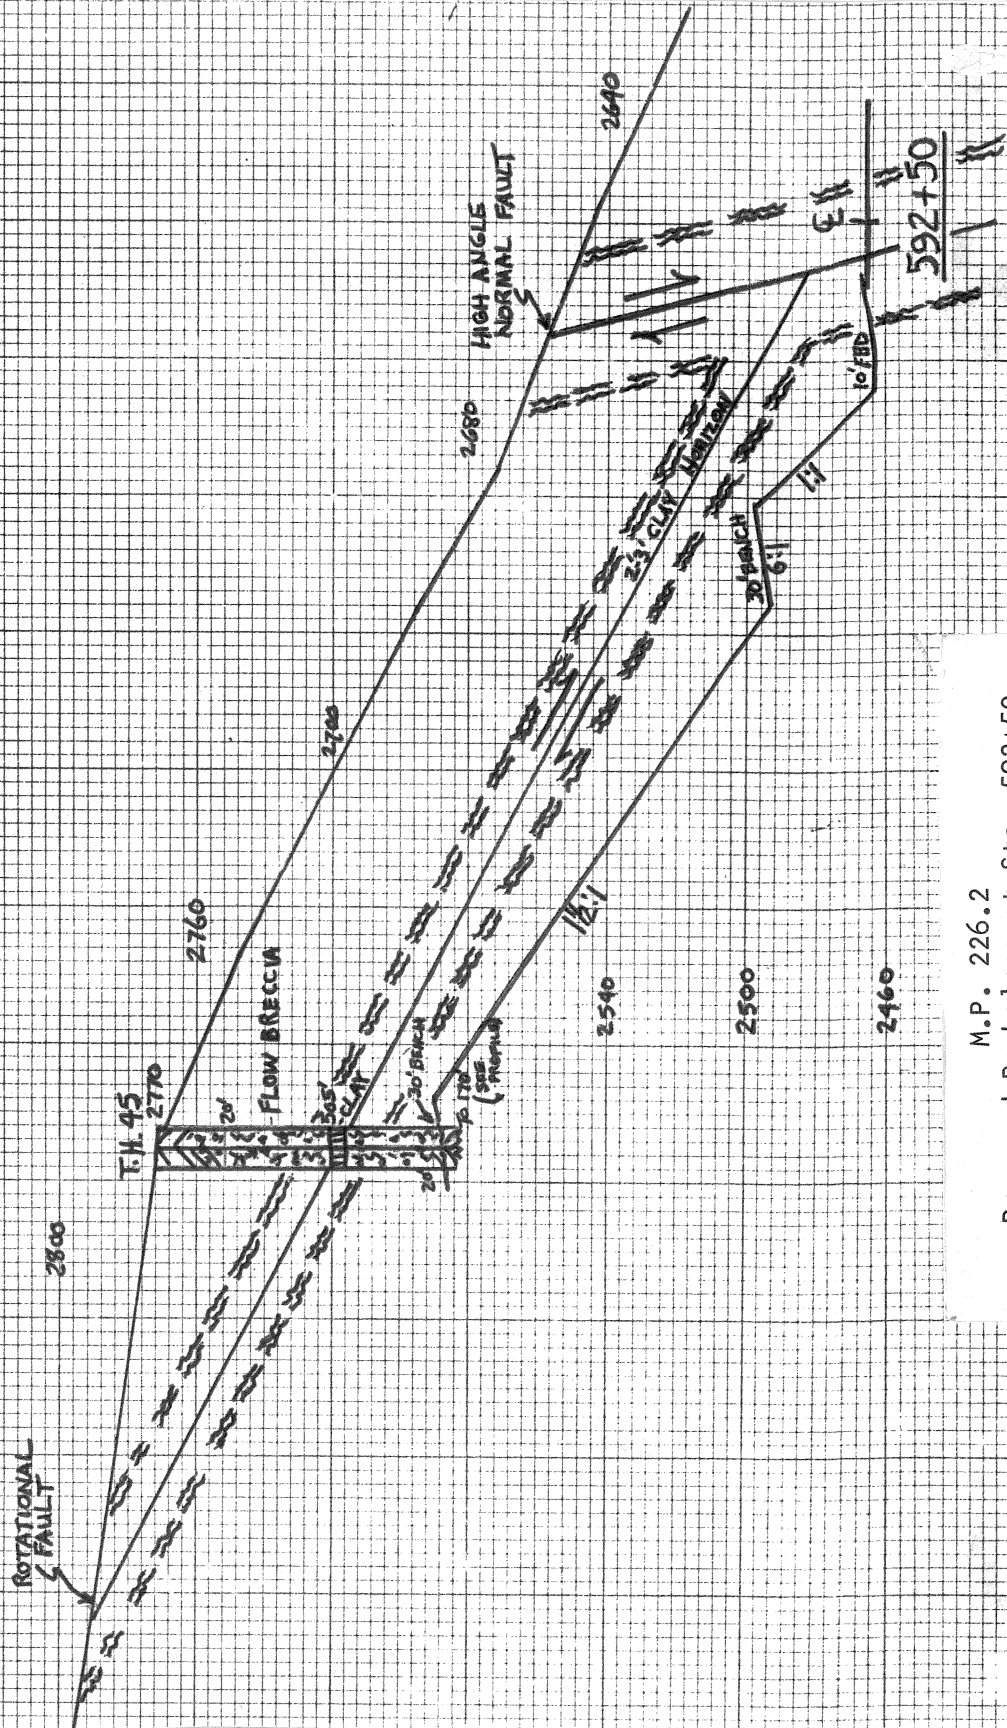
FIGURE NO. 2

M.P. 226.2
Proposed Backslope at Sta. 592+50

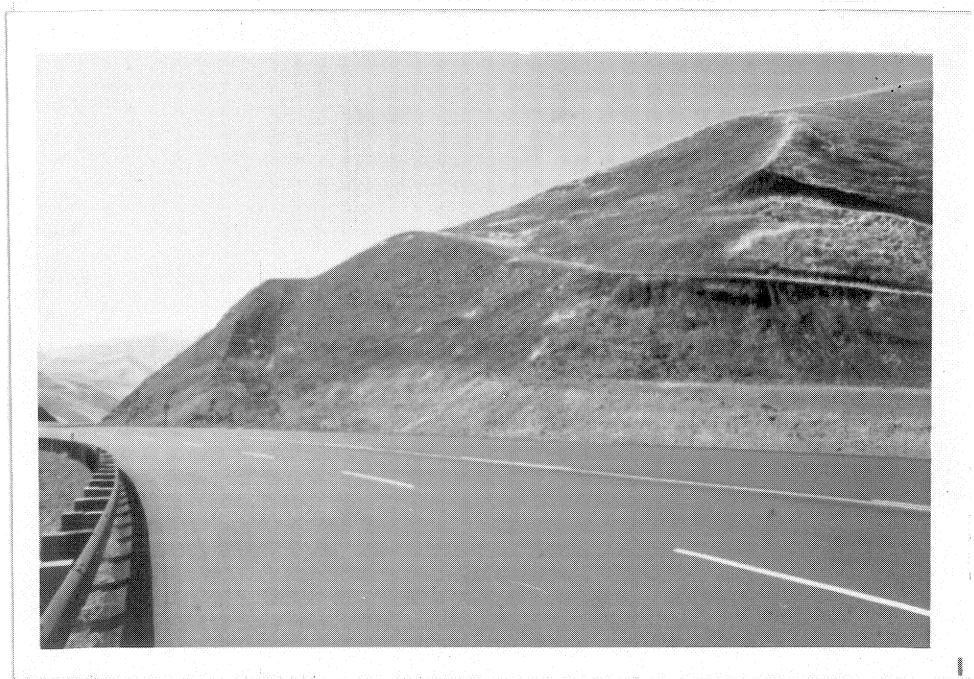
PHOTO NO. 7

Constructed Backslope at Sta. 590

Approximately one million yards of material was removed from this cut, with this design. There has not been any subsequent movement or sluff. There of course, has been some criticism, saying the cut was over-designed, primarily because it has not failed.

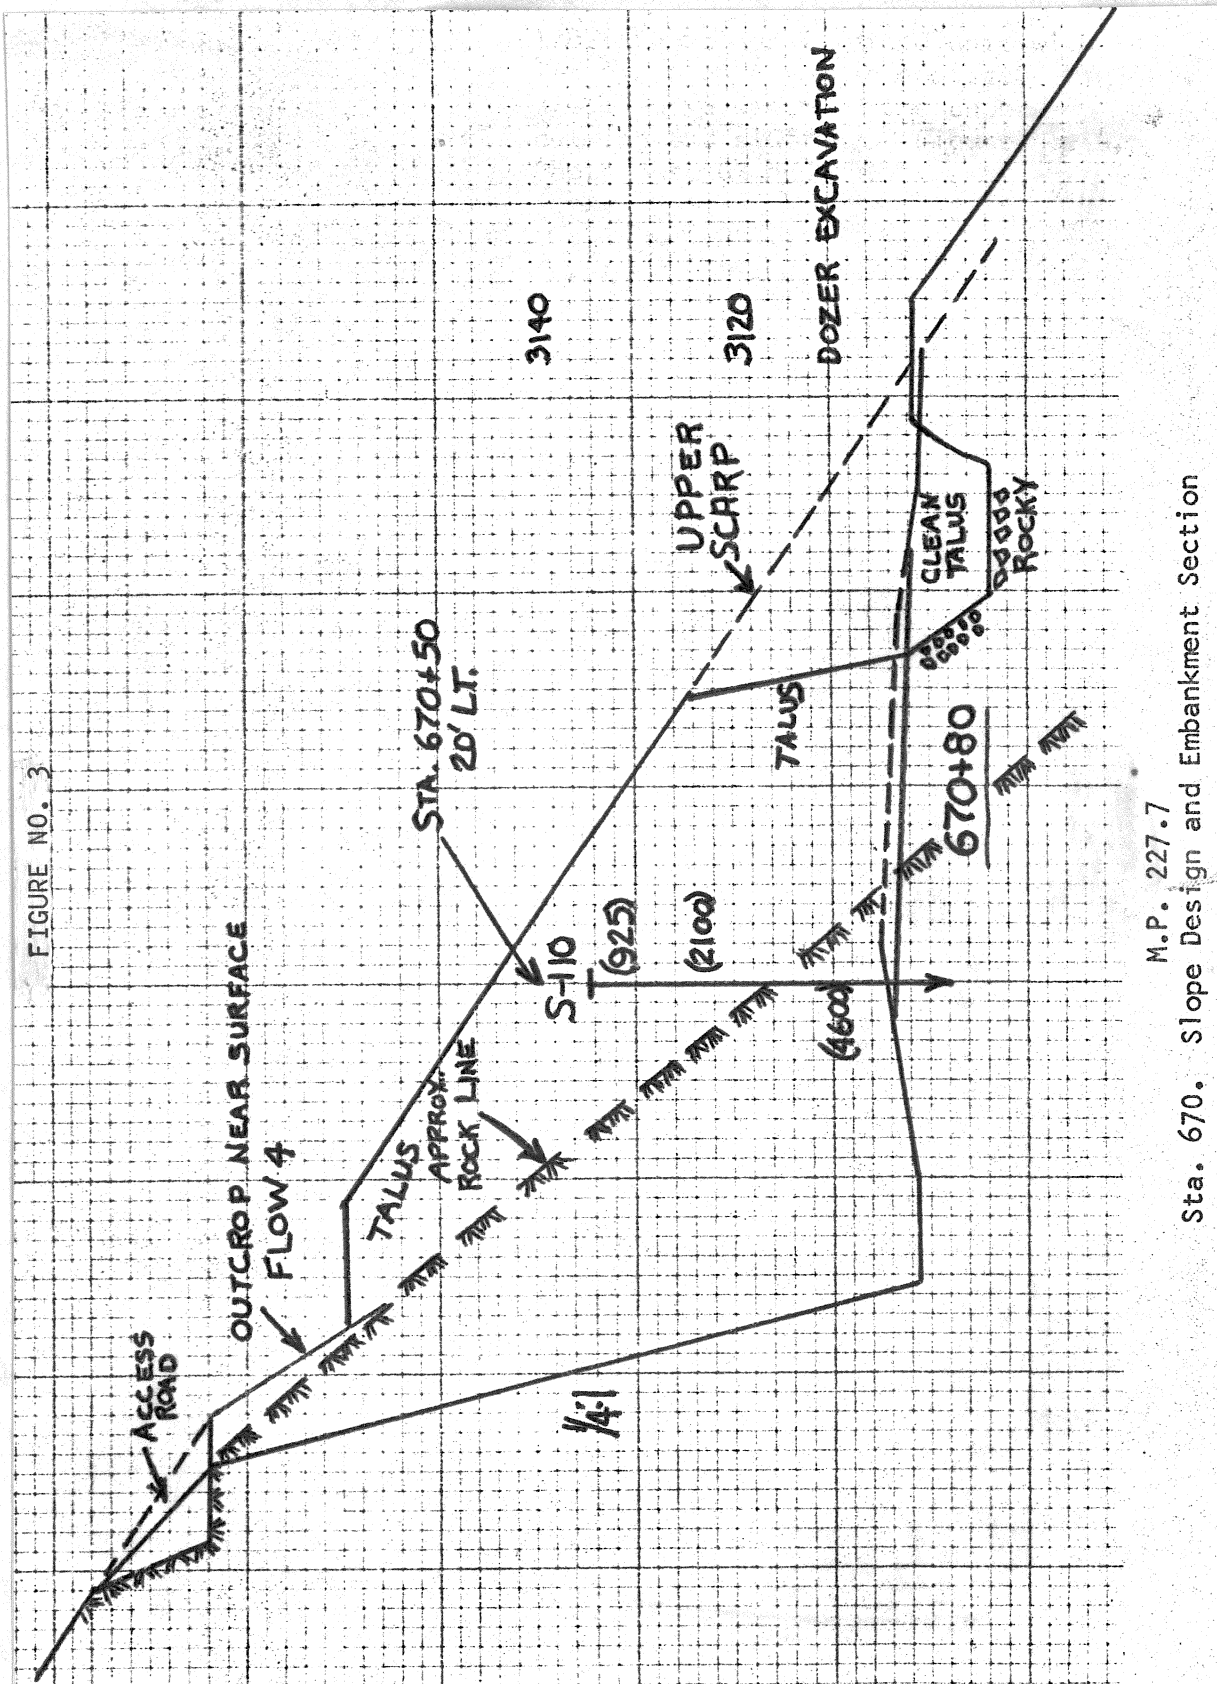
This area, (Figure No. 3) was defined as potentially unstable as existing tension cracks were present on the natural hillside. Deep talus was resting unconformably on a soil terrace. If failure occurred the two outer lanes of the proposed highway would be displaced. Seismic traverses were used to delineate the depth of the soil and talus and rock line (Figure No. 3). A dozer trench was placed to determine the amount of variation within the talus deposit, and if any thin, but detrimental clay or ash horizon was present. None was found.

M.P. 227.7
Sta. 670. Slope Design and Embankment Section

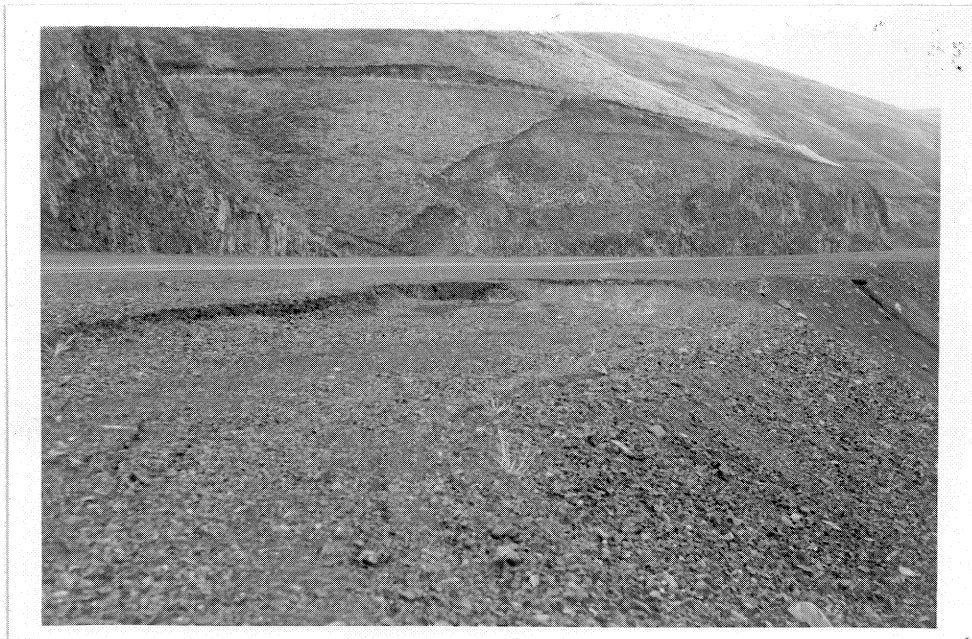
PHOTO NO. 8

The first indication occurred during November 1970 (Photo No. 8) in which an arcuate scarp had developed along the talus-bedrock interface. By January 1971 the vertical drop was between one and two feet. Fourteen months later the vertical drop was over eight feet in places and had extended into the diced bedrock, (Photo No. 9).

Sta. 670. Failure Plan "E" Developing After Wasting on Hanging Terrace

At this time it was decided some corrective action was necessary as the slip plane was continuing to grow and new tension cracks were forming.

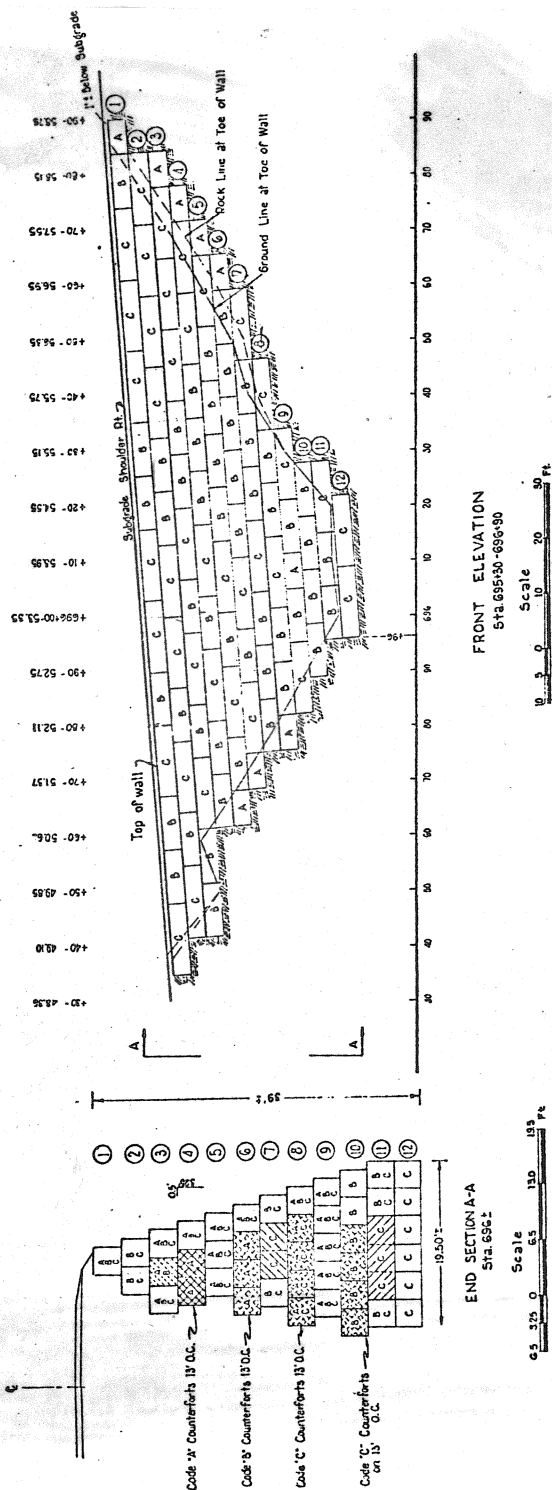
FIGURE NO. 4

M.P. 228.2
Plan Sheet of Proposed Gabion Retaining Wall

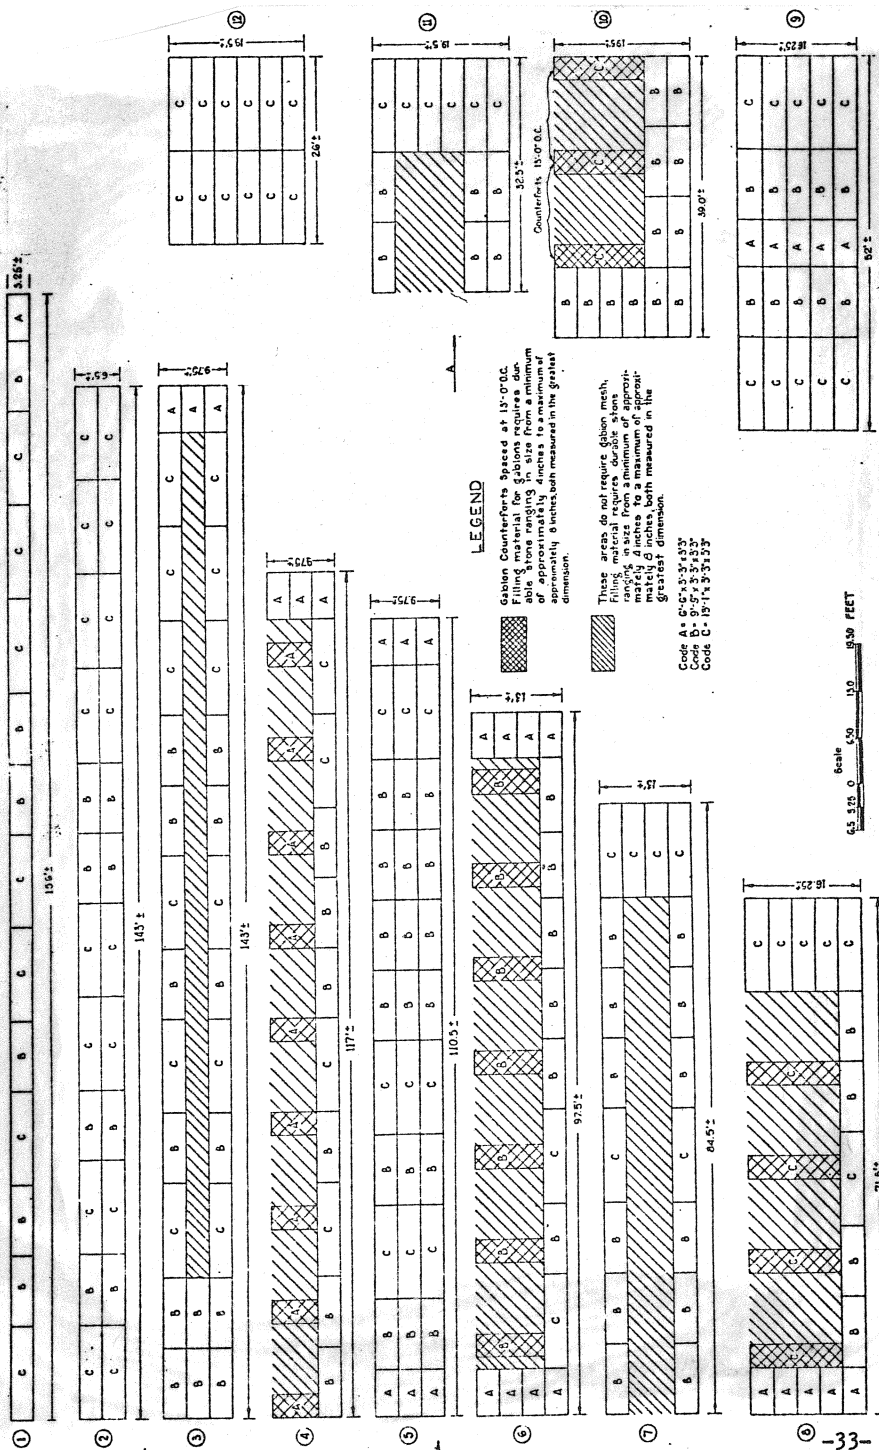
M.P. 228.2

Internal Counterfort Design of Gabion Wall

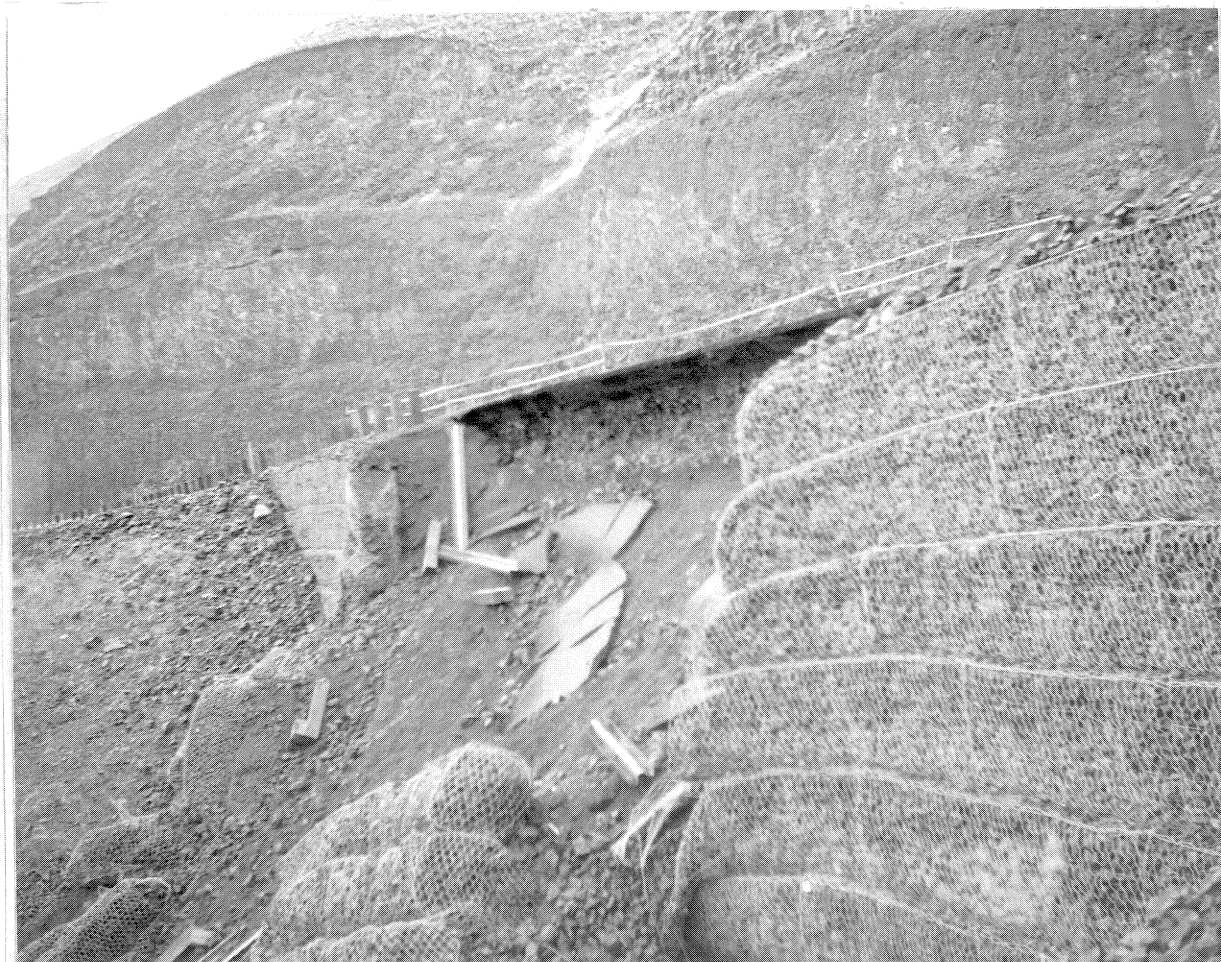
PHOTO NO. 10

After the failure a backhoe was used to paw around to see where the collapse had occurred. Field examination showed that Course No. 7 of the open rock crib began to bulge taking the front row of Course No. 8 with it. The counter-forts of Course No. 8 were still in place. This was an internal failure due not only to an inadequate design but also to construction procedures. Don't use an open crib design on a relatively high wall. Colorado Highway Department has experienced similar results (Personal Communication).

M.P. 228.2
Gabion Failure

After the failure the design criteria from the Manufacturer changed radically, which increased the cost roughly 100 percent. This included turning the baskets 90° to centerline which increased the rock quantity by nearly double. The twist ties to hold the baskets together were now obsolete. The Manufacturer recommended a spiral lacing procedure. Also the front row of rock facing in the cribs which is the outer wall surface should be hand-placed to insure total stability. A metal bin wall was put

in as the replacement and has performed very well to date.

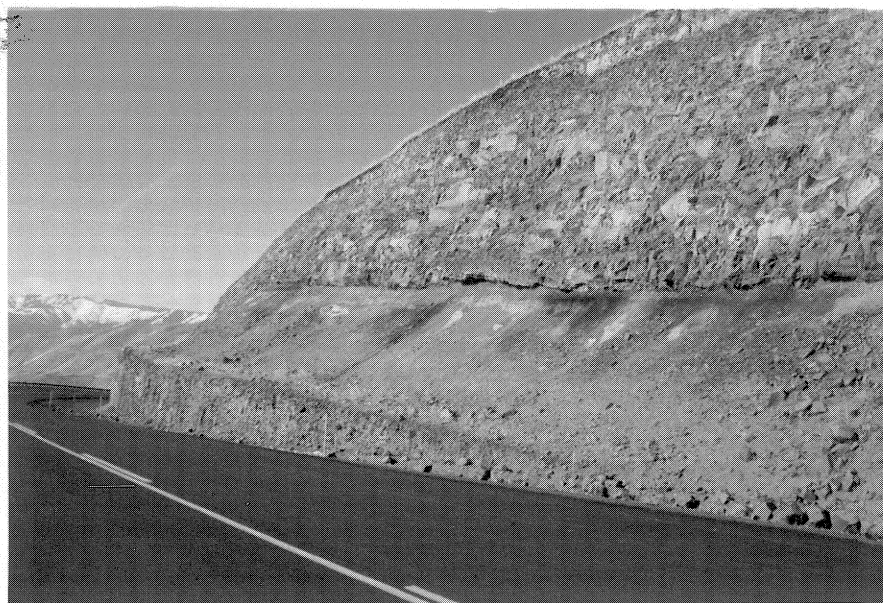
PHOTO NO. 11

Once the thickness and characteristics of the interbed had been determined, benching was the next consideration as the height of the cut was considerable. It was finally determined that benching below the interbed, within the tightly jointed, diced basalt unit would be the most satisfactory. This was determined by seismic analysis as the velocity in this unit was nearly twice as much as the overlying unit, even though the rock quality was the same, Photo No. 11.

M.P. 229.20
Sta. 757 + 50. Constructed Backslope

During construction, it was discovered that a small fault (30' through) intersected the backslope which meant that the bench was composed of interbed material in part rather than in the diced unit as proposed. A post construction examination shows that the outer 3.0' of the bench is in danger as tension cracks are present. The interbed has also undercut the overlying columnar unit which has caused minor rock fall onto the bench.
